DTC	C2176/76	Receiver Error
-----	----------	----------------

DESCRIPTION

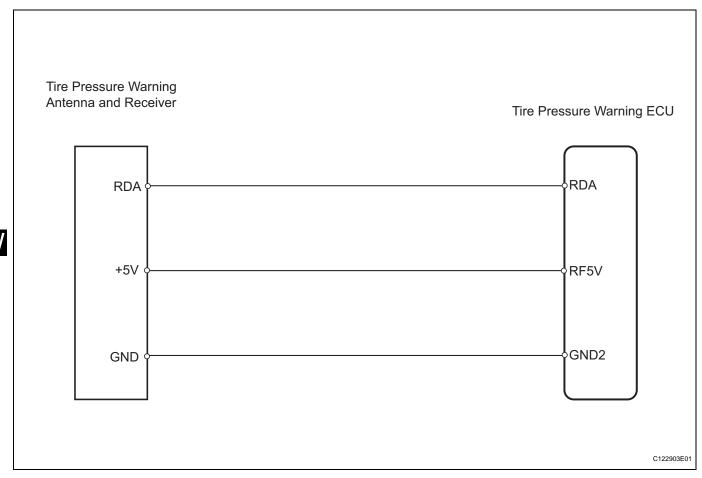
WIRING DIAGRAM

The signals are transmitted to the tire pressure warning antenna and receiver on the body as radio waves and then sent to the tire pressure warning ECU.

DTC No.	DTC Detection Condition	Trouble Area
C2176/76	 When either of following detected: EEPROM in tire pressure warning ECU malfunction Terminal RF5V shorted to ground 	 Tire pressure warning antenna and receiver Tire pressure warning ECU Wire harness or connector
